RE: Air and Wipe Sampling in Select Areas – March 2017 – Update
Sky Valley Educational Center, 351 Short Columbia Street, Monroe, Washington

On Monday, March 6, 2017 and Monday, March 13, 2017, Fulcrum Environmental Consulting, Inc. (Fulcrum) completed a sampling event at Sky Valley Educational Center for the presence of polychlorinated biphenyls (PCBs) in air and on non-porous surfaces. The purpose of the sampling event was to evaluate seven areas that were found during the previous event to have detectable levels of PCBs. In addition, Fulcrum collected samples from four other locations, each an electrical room, which had not been previously evaluated. See Attachment A for site photographs.

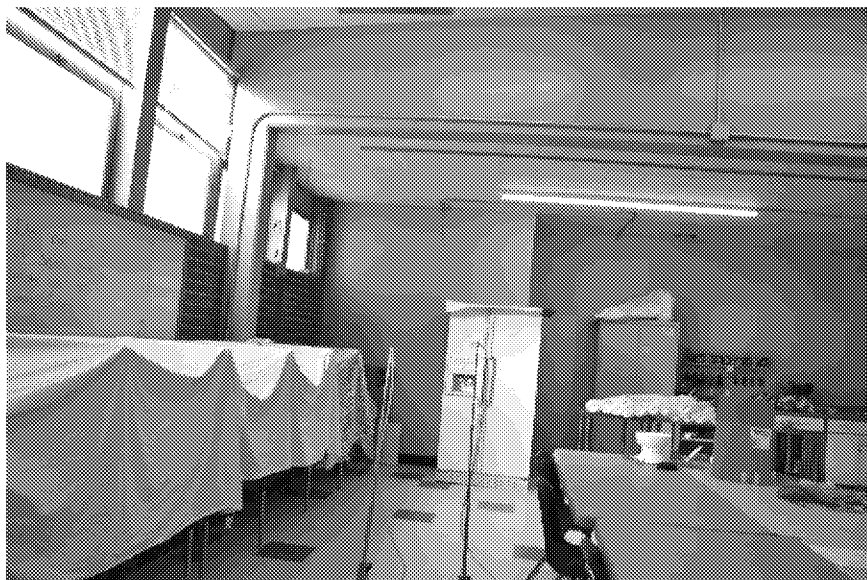
- During collection of sample 030617-07 in the CTE Room, an exterior window was observed to be open. It was unclear how long the window had been opened. As a result, following discovery of the open window, sample collection continued, the sample was returned to ALS-Cincinnati, but analysis was not requested.
- During collection of sample 030617-09 in the CTE Electrical Room the sample glass cassette fell from the sampling tube onto the ground and broke. As a result, the sample was returned to ALS-Cincinnati; however, sampling analysis could not be completed.
- In addition to the broken cassette, the collocated air sampling was stopped in the CTE Electrical Room after it was discovered that the door to the CTE Electrical Room had been left open. As a result, air exchange between the CTE Room and CTE Electrical Room was not collected under conditions that would be typical of the spaces.

030617-07: CTE Classroom.

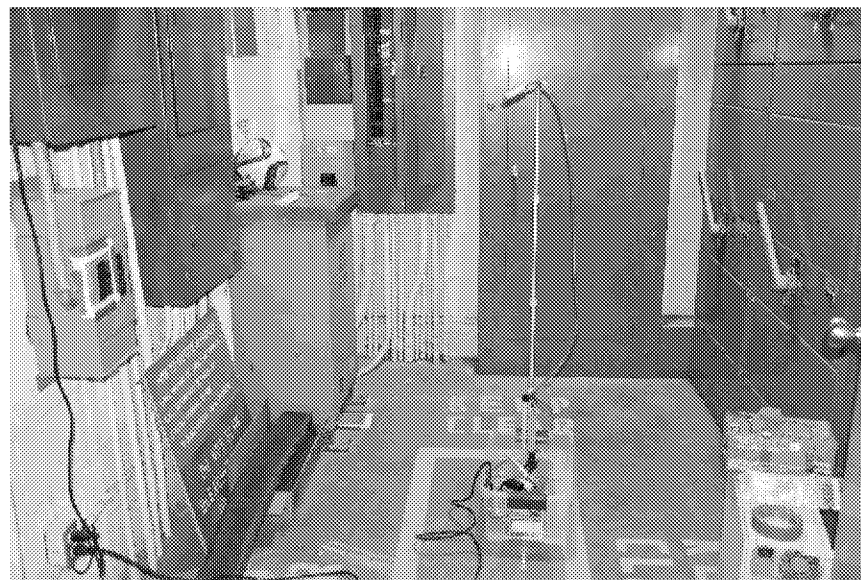
030617-08: Large Gym – Electrical Room.

Laboratory analysis identified low concentrations of Aroclor 1260 on the concrete floors in the Large Gym Electrical Room and the CTE Electrical Room. While remediation is not required based on the PCB concentrations present, Fulcrum recommends that the District consider implementation of best management practices where practicable and feasible and with the overall goal of reducing the presence of detectable PCBs within the building.

As such, Fulcrum recommends that the floor surfaces within each of the electrical rooms be cleaned of free dust by trained District staff or a qualified remediation contractor. Furthermore, given the difficulty of cleaning the porous concrete surface, Fulcrum recommends application of an approved paint/sealer to the concrete floors. Given the potential for unpleasant odors associated with the paint/sealer, Fulcrum recommends that application occur as build use and school schedules permit.

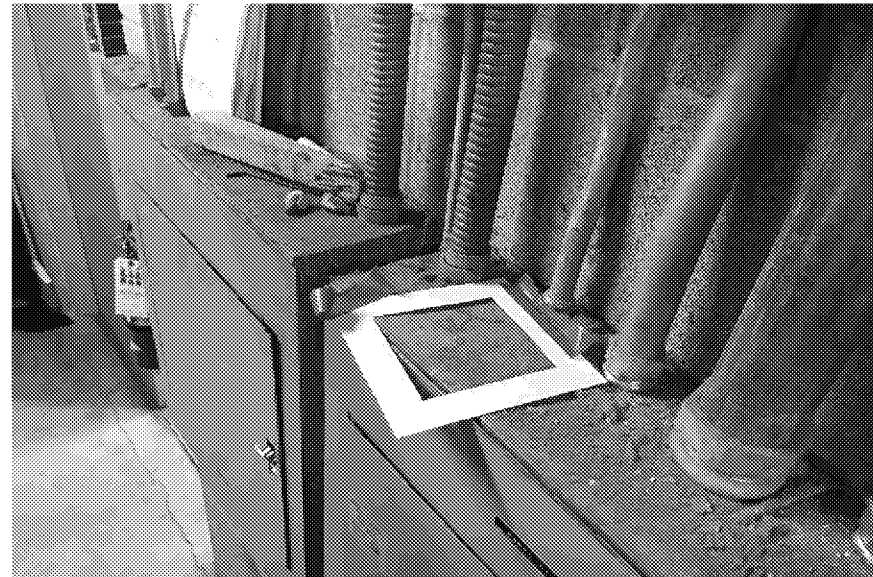
030617-12: Small Gym – Electrical Closet. Sample taken directly below transformer on electrical box.

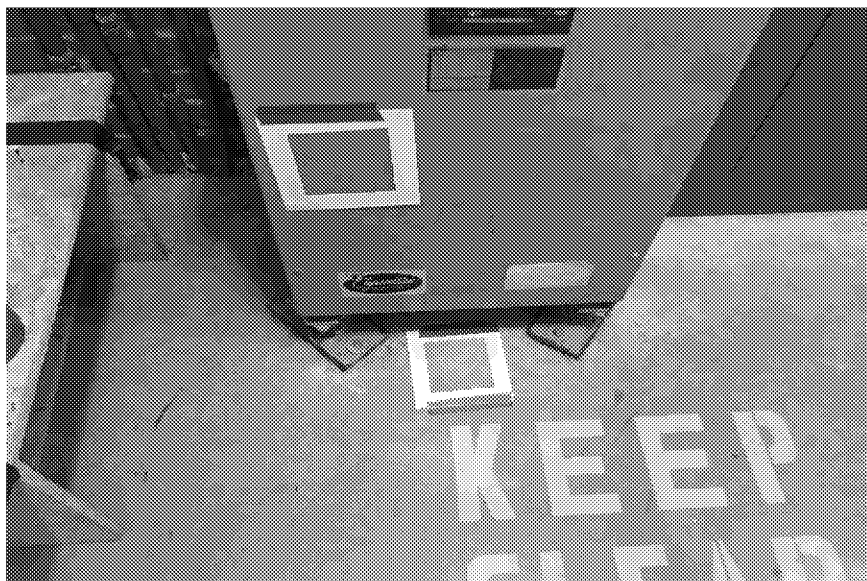
Aroclor 1260 were present in samples from the concrete floors in the Large Gym Electrical Room and the CTE Electrical Room. Both wipe samples were reported with total PCB concentrations below the EPA threshold of 10 micrograms (µg) per 100 cm².

030617-15 & 030617-16: CTE Classroom – Electrical Room. Samples collected from the side of the transformer and directly below transformer on concrete floor.

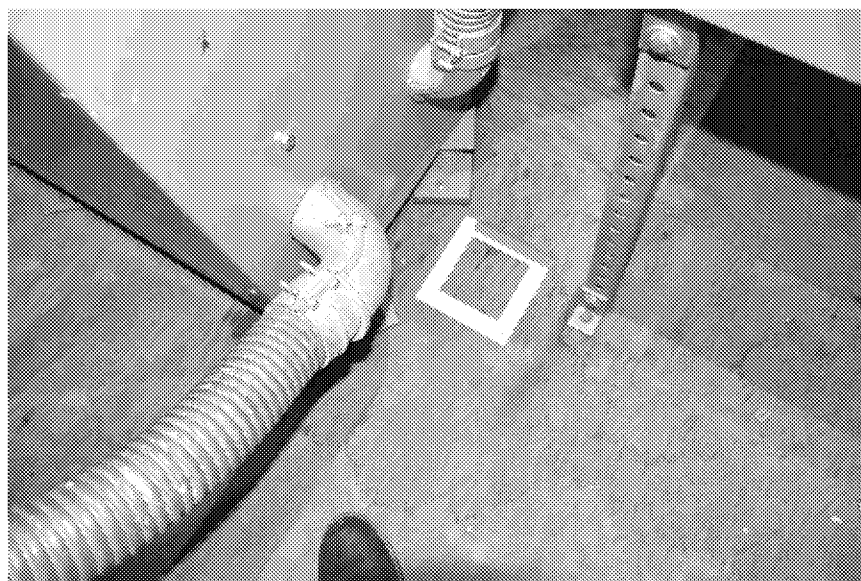
030617-17: West Pod – Mezzanine. Sample collected on the wood flooring directly below the transformer. Slight staining was observed.

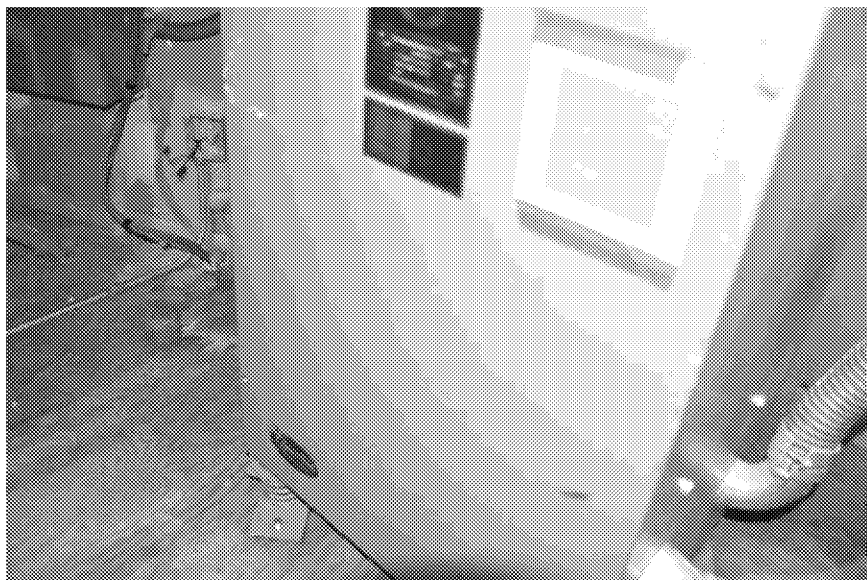
030617-18: West Pod – Mezzanine. Sample taken from side of transformer. No staining or streaking was observed.
